**Chino Mines Company**  
**Hurley, New Mexico**

**Administrative Order on Consent**  
**Interim Remedial Action**  
**Groundhog Mine Stockpile**  
**Site Investigation Report**  
**Hanover and Whitewater Creeks Investigation Unit**

October 9, 2000

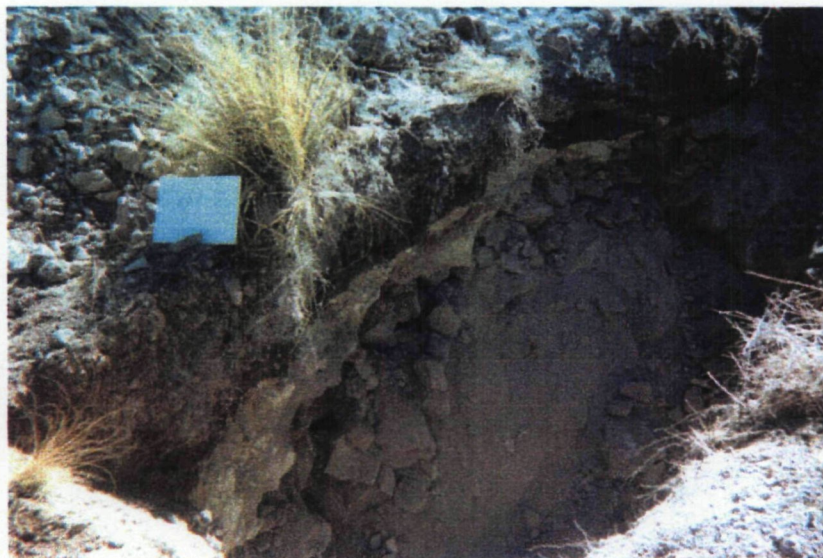
TEST PIT G1-2  
 TEMP \_\_\_\_ °F WEATHER \_\_\_\_\_ ENGINEER Jen Pepe OPERATOR G. Shepard  
 EQUIPMENT 235 Cat Excavator CONTRACTOR James Hamilton Construction DATE 6/15/00  
 ELEVATION 6121.0 DATUM \_\_\_\_\_ JOB 003-2562  
 LOCATION Groundhog Mine, New Mexico

- ④ Bedrock (SUGARLUMP TUFF).

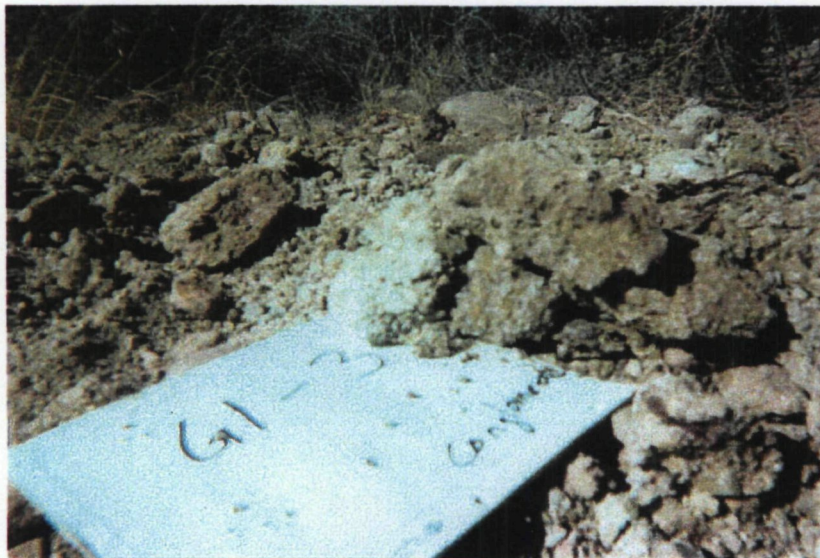
TEST PIT G1-3  
 TEMP \_\_\_\_ °F WEATHER \_\_\_\_\_ ENGINEER Jen Pepe OPERATOR G. Shepard  
 EQUIPMENT 235 Cat Excavator CONTRACTOR James Hamilton Construction DATE 6/14/00  
 ELEVATION 6095.6 DATUM \_\_\_\_\_ JOB 003-2562  
 LOCATION Groundhog Mine, New Mexico

- ① (0'-4') Mixed light brown sand with gravel and dark brown clay lenses with dense roots. Gravelly sand is slightly moist, cobbles are quartz granitics and porphyry, mudstone, and tuff, and minor pink/green altered granite. Clay lenses are moist, highly plastic, with white and yellow staining/precipitates. (MIXED FILL)
- ② (4'-24') (SW) Gravelly sand, yellowish brown (2.5 YR 7/3), fine sand to gravel less than 1" (occasional cobbles to 8"), subangular to subrounded. Lithics are mudstone, feldspar, mica, tuff, chert, and pink/green altered granite. Weakly to moderately cemented, some preferred orientation of clasts in irregular intervals, no discrete bedding. Possibly natural conglomerate (no stockpile materials identified in this interval). Generally moist, becoming wet with weathered clasts at base of interval. (CONGLOMERATE)

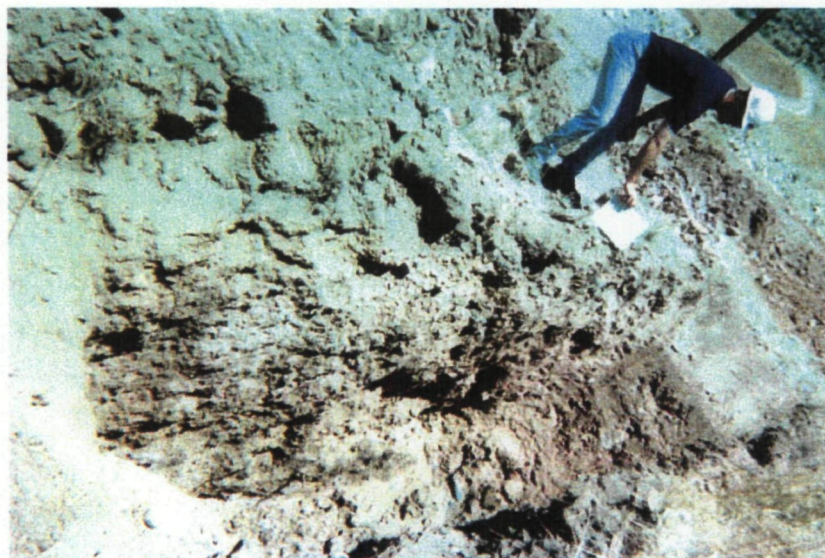
TEST PIT G2-1  
 TEMP      °F WEATHER      ENGINEER Jen Pepe OPERATOR G. Shepard  
 EQUIPMENT 235 Cat Excavator CONTRACTOR James Hamilton Construction DATE 6/14/00  
 ELEVATION 6082.9 DATUM      JOB 003-2562  
 LOCATION Groundhog Mine, New Mexico

- ① (1'-1.5") (COVER SOIL).
- ② (1'-7.5") (GW) Well graded gravel with sand, 20% > 1.5", mixed rounded fine-grained tuff and angular glassy coarse-grained tuff, quartz granite and minor porphyry w/feldspar and pyrite phenocrysts. Some moderately cemented soil aggregates, but mostly loose, no plasticity, moist. Occasional lense of dark brown clay with roots and some yellow Fe oxide precipitates. (FILL)
- ③ (7.5'-9.5') Mixed fill (as above) and fractured bedrock (as below) with roots present. (MIXED FILL/COLORADO FORMATION).
- ④ Fractured siltstone, blocky, gray (2 YR 8/1) with red weathering rinds and veins (2 YR 6/8), up to 1'. Fine fraction slightly moist, reddish brown, no plasticity. (COLORADO FORMATION WITH QUARTZ VEINS).

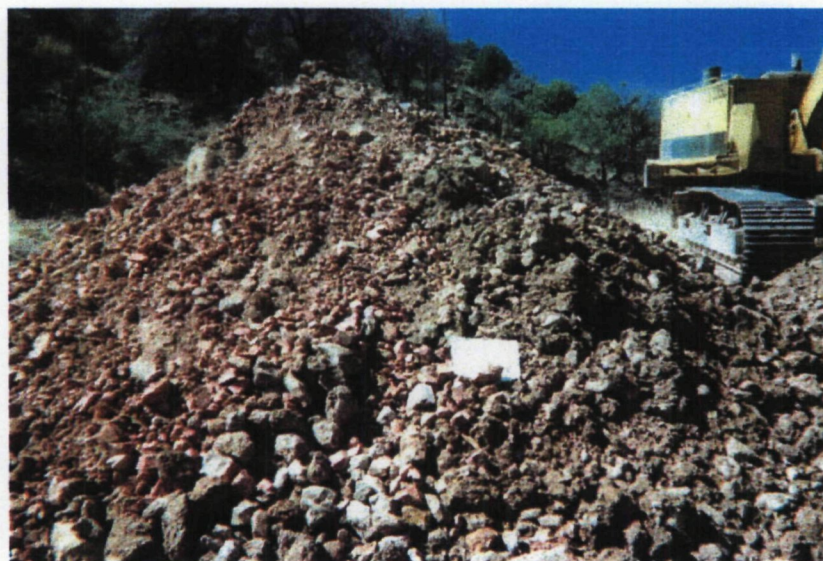
TEST PIT G2-2  
 TEMP \_\_\_\_ °F WEATHER \_\_\_\_\_ ENGINEER Jen Pepe OPERATOR G. Shepard  
 EQUIPMENT 235 Cat Excavator CONTRACTOR James Hamilton Construction DATE 6/14/00  
 ELEVATION 6077.9 DATUM \_\_\_\_\_ JOB 003-2562  
 LOCATION Groundhog Mine, New Mexico

- ① (2'-12') (GC) Clayey gravel with sand, dark brown, 50% > 1.5", up to 3' boulders, larger boulders are tuff, other lithics are fine to coarse grained pink and white granite, porphyry with pyrite phenocrysts, and minor small (<2") cobbles and gravel of chrysocolla. Thin veins of chrysocolla, galena, and associated minerals in porphyry cobbles. Moist to wet, highly plastic. Clay lenses with Fe oxides (jarosite, hematite) and blue Cu hydroxide precipitates. Thin clay weathering rinds on clasts. (STOCKPILE MATERIAL)
- ② (12'-14') Mixed fractured bedrock (as below) and thin dark brown soil layers with roots. (MIXED SOIL HORIZON/COLORADO FORMATION).
- ③ Fractured siltstone, blocky, gray (2 YR 8/1) with red weathering rinds (2 YR 6/8), up to 1'. Fine fraction slightly moist, reddish brown, no plasticity. (COLORADO FORMATION WITH QUARTZ VEINS).

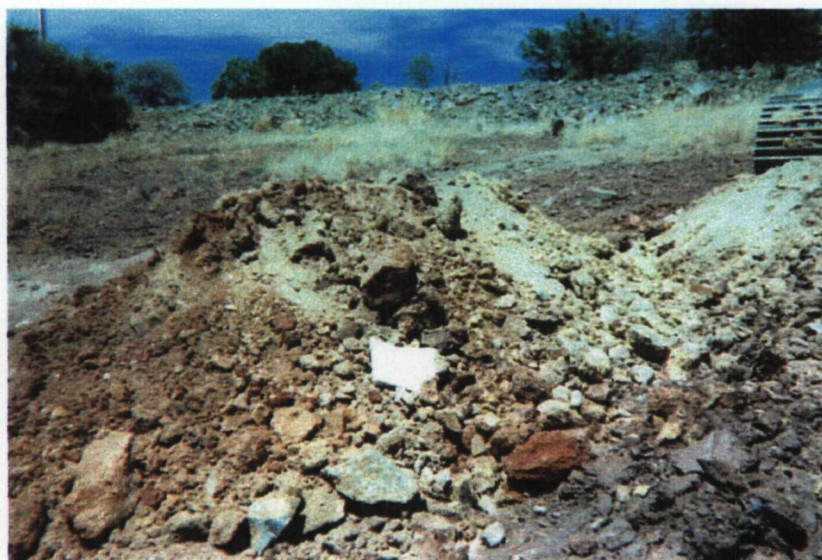
TEST PIT G3-1  
 TEMP \_\_\_\_°F WEATHER \_\_\_\_\_ ENGINEER Jen Pepe OPERATOR G. Shepard  
 EQUIPMENT 235 Cat Excavator CONTRACTOR James Hamilton Construction DATE 6/13/00  
 ELEVATION 6080.9 DATUM \_\_\_\_\_ JOB 003-2562  
 LOCATION Groundhog Mine, New Mexico

- ⑤ Slightly weathered pink/green altered granite. (WEATHERED BEDROCK)

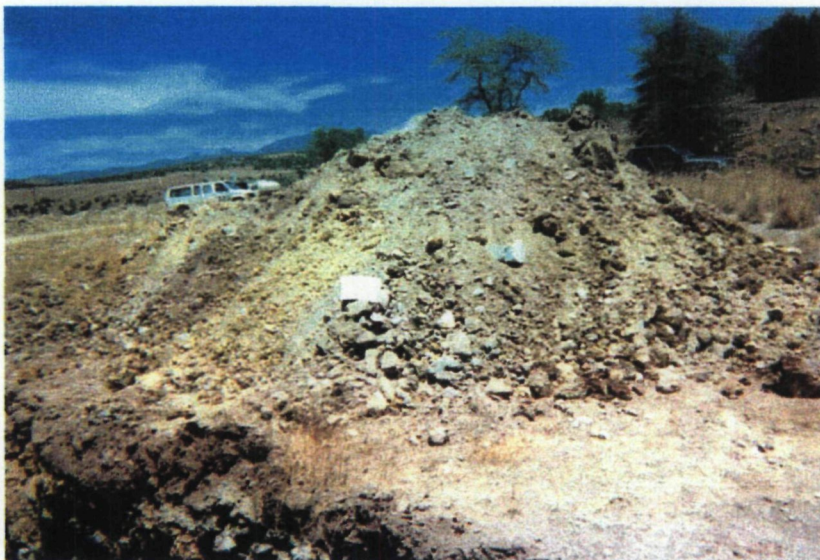
TEST PIT G3-2  
 TEMP \_\_\_\_°F WEATHER \_\_\_\_\_ ENGINEER Jen Pepe OPERATOR G. Shepard  
 EQUIPMENT 235 Cat Excavator CONTRACTOR James Hamilton Construction DATE 6/13/00  
 ELEVATION 6064.3 DATUM \_\_\_\_\_ JOB 003-2562  
 LOCATION Groundhog Mine, New Mexico

- ⑤ Pink/green altered granite (BEDROCK)

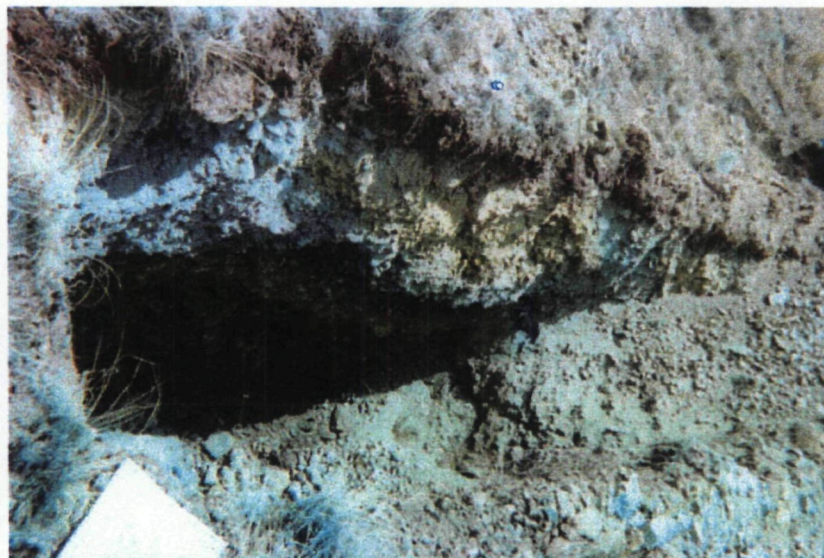
TEMP 80 °F WEATHER Fair TEST PIT G3-4  
 EQUIPMENT 235 Cat Excavator ENGINEER Jen Pepe OPERATOR G. Shepard  
 ELEVATION 6046.3 CONTRACTOR James Hamilton Construction DATE 6/12/00  
 LOCATION Groundhog Mine, New Mexico DATUM \_\_\_\_\_ JOB 003-2562

- ① (1'-7') (GP-GM) Poorly graded gravel with sand and fines, yellowish orange to gray in approx. 2' lenticular beds, 50%-85% >1.5", including quartz porphyry with feldspar and mica phenocrysts, and limestone and dolomite (some mineralized with pyrite, galena, and Cu hydroxides). Angular cobbles up to 1' diameter. Low to medium plasticity, loose to medium dense, slightly moist to moist (increasing with depth), weak to strong reaction with HCl (becoming weaker with depth). Soft jarosite and limonite weathering rinds on cobbles at base of interval. (STOCKPILE MATERIAL)
- ② (7'-11.5') (GC) Clayey gravel with sand, color varies, 60% >1.5", primarily blocky angular dolomite, limestone mudstone, and pink fine-grained granite. Very moist, highly plastic, reacts with HCl. Dark brown clay lenses. (DISTURBED ORIGINAL SURFACE)
- ③ Pink/green altered granite (BEDROCK)

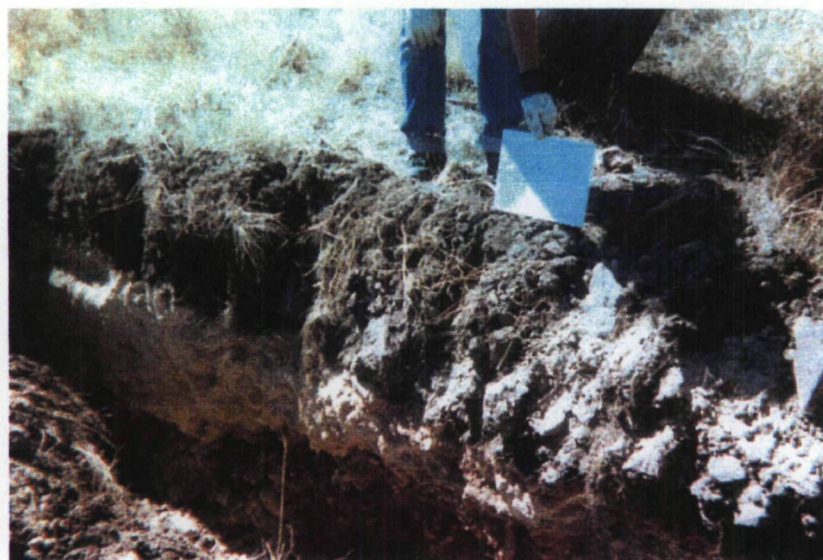
TEST PIT G4-1  
 TEMP      °F WEATHER      ENGINEER Jen Pepe OPERATOR Pam Ammons  
 EQUIPMENT Cat Backhoe 2689 CONTRACTOR James Hamilton Construction DATE 6/20/00  
 ELEVATION 6007.9 DATUM      JOB 003-2562  
 LOCATION Groundhog Mine, New Mexico

- ① (0'-1.5') Dark brown blocky cover soil. (COVER SOIL).
- ② (1.5'-6') (SC) Gravelly sand with clay, yellowish (10YR 7/4), 10% > 1.5", primarily weathered granite and tuff with some quartz porphyry with disseminated fine pyrite crystals. Slightly moist, moderate plasticity. Lense of angular cobbles (3"-4" diam.) at 5 foot depth, primarily tuff with minor quartz porphyry. (MIXED STOCKPILE MATERIAL AND WEATHERED GRANITE)
- ③ (6') (SC) Thin layer of sandy clay, dark brown to reddish brown, with occasional cobbles of weathered tuff. Moist. Roots and gypsum crystals present. (ORIGINAL SURFACE)
- ④ Fractured, weathered tuff. (SUGARLUMP TUFF)
